Taming the Flutter Monster

BY MARTIN HOLLMANN

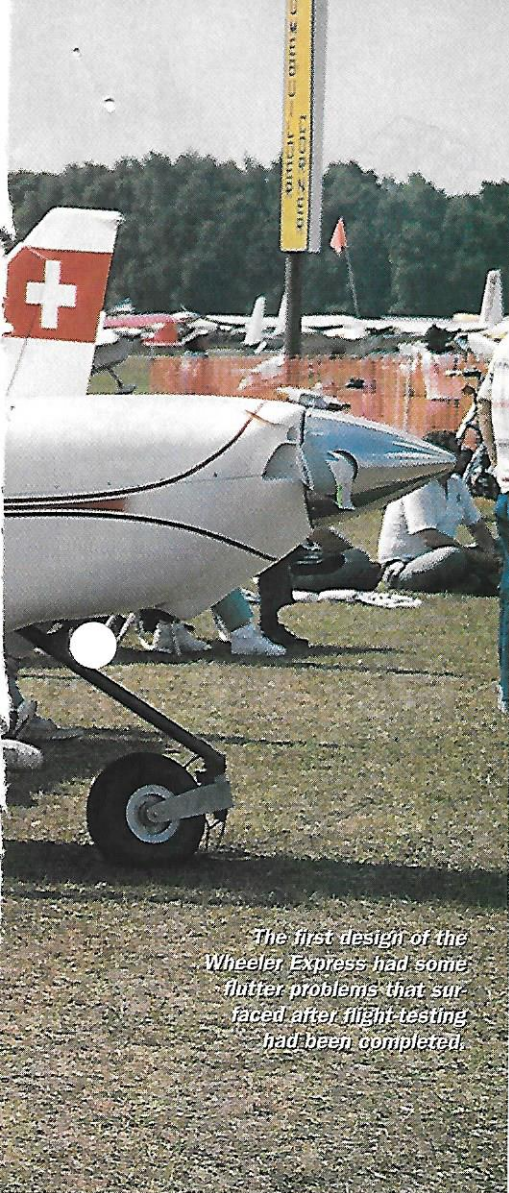
The first design of the Wheeler Express had some flutter problems that surfaced after flight testing had been completed.

Shortly thereafter the first kit Wheeler Express took to the air. Just after takeoff, in severe turbulence, the empennage began to vibrate at 85 to 90 knots. The severity of the noise still haunts both of the pilots today. The aircraft returned to land, and it was found that severe delamination occurred around the horizontal-tail to vertical-tail attachment. Both of these aircraft had the same tail configuration and attachment. Because of the severe delamination, flutter was suspected.

I then stiffened up the horizontal-stabilizer to vertical-tail attachment and used the tail weights of Ed Bernard's Wheeler Express and reran the flutter analysis. The new analysis showed that no flutter existed for this model. Needless to say, I have been recommending to all Wheeler Express builders that the tail be properly attached. To date, no other flutter problems have been encountered on this sleek, high-performance, composite aircraft.

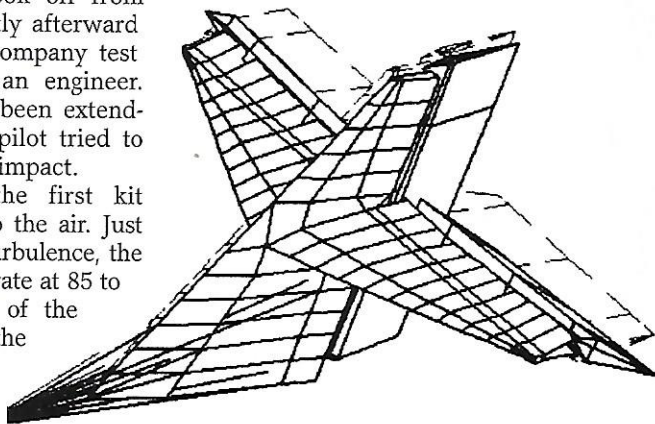
The computer program revealed a flutter mode at 11.79 Hz. Both the deflected and nondeflective modes are shown.

The FEA results were used in setting up an input file for the SAF flutter program, and after three weeks of hard work, the SAF showed that elevator deflection frequency of 11.79 Hz crossed zero damping at 87.7 knots and that it coupled with horizontal-

stabilizer bending of 8.1 Hz. Another critical flutter speed occurred at 328 knots. Betts had not told me the speed at which he had encountered flutter. But when I told him of the flutter results, we were both surprised at the accuracy of the analysis.

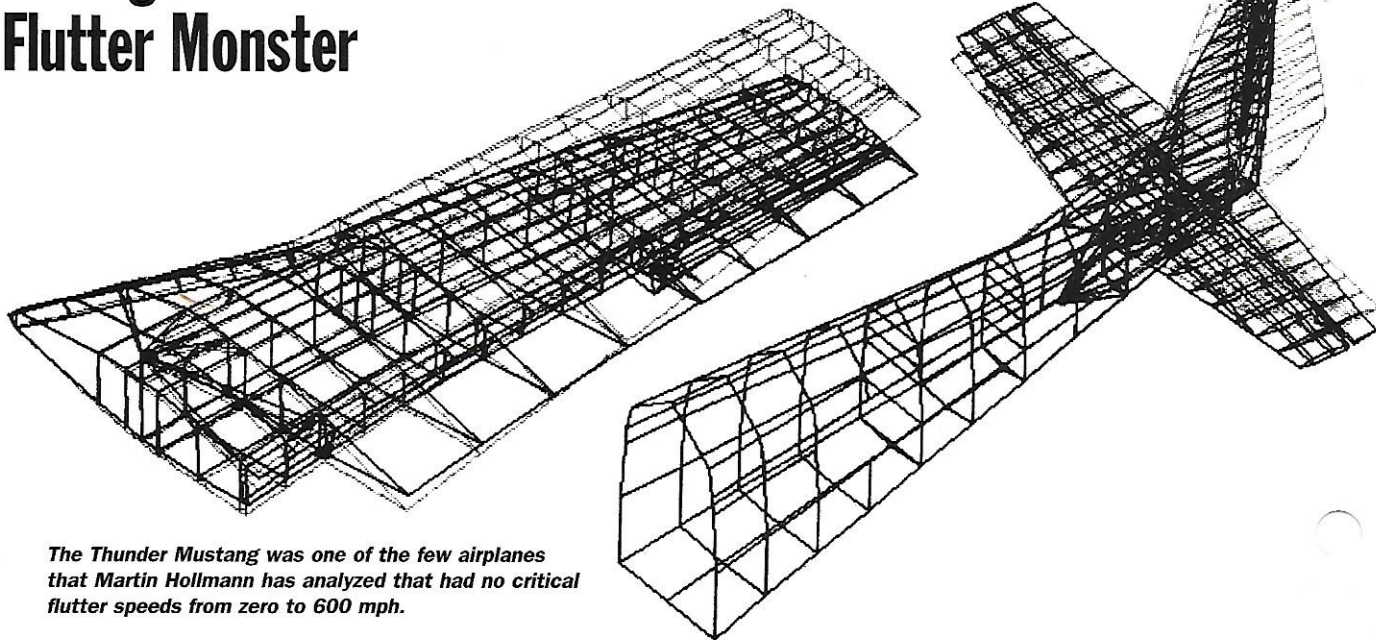
The Thunder Mustang was one of the few airplanes that Martin Hollmann has analyzed that had no critical flutter speeds from zero to 600 mph.

After performing the flutter analysis and viewing the structure that the in-house engineers had designed, I told Denney that the skin thickness was twice what it needed to be, and he stated that the aircraft was too heavy. We reduced the skin thickness and replaced the aluminum honeycomb with Nomex honeycomb core and reran the flutter analysis. Again, no critical flutter speeds were found. Friezner performed the GVT to verify the frequencies and determine the structural damping.

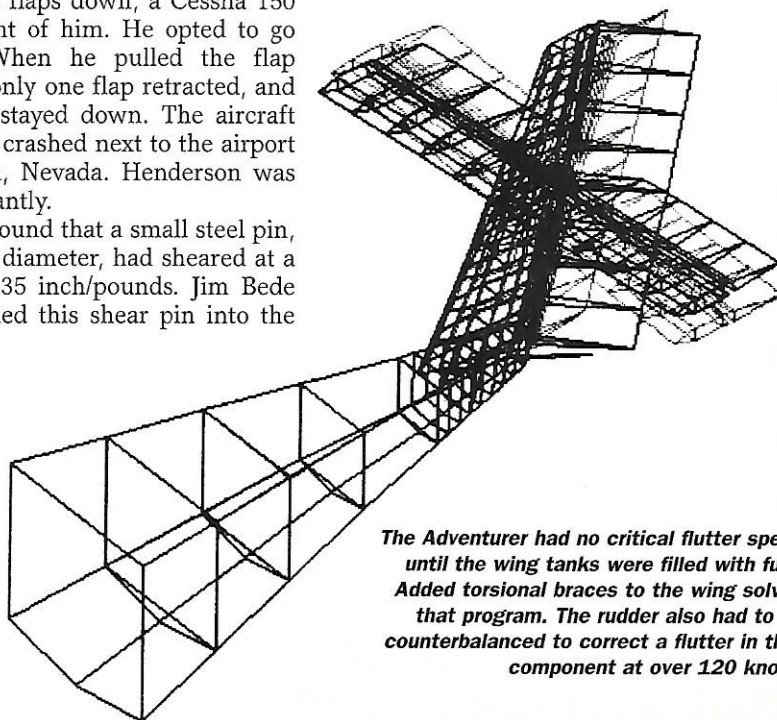
The Adventurer had no critical flutter speed until the wing tanks were filled with fuel. Added torsional braces to the wing solved that program. The rudder also had to be counterbalanced to correct a flutter in that component at over 120 knots.

I performed a stress analysis and a flutter analysis. The flutter analysis of the empty wing with the ailerons balanced showed no critical flutter speed from 0 to 600 knots. However, with 30 gallons of fuel in the wing, a critical flutter speed of 94.3 knots was determined.

Only one lift strut is used for each wing, and only the leading edge torsion box and the fabric of the wing provide torsional stiffness to the wing, so very little torsional stiffness exists. As such, no fuel may be added to the wing. A flutter analysis of the tail showed that the tail had a critical flutter speed of about 120 knots. With the addition of 10 pounds of counterbalance weight to the rudder, the critical flutter speed of the tail goes to 196 knots. As such, counterbalancing to the rudder is necessary.
