How Strong Does It Have To Be?

By M. B. Taylor (EAA 14794)

Chief Engineer — AEROCAR, INC. Box 1171 Longview, Washington

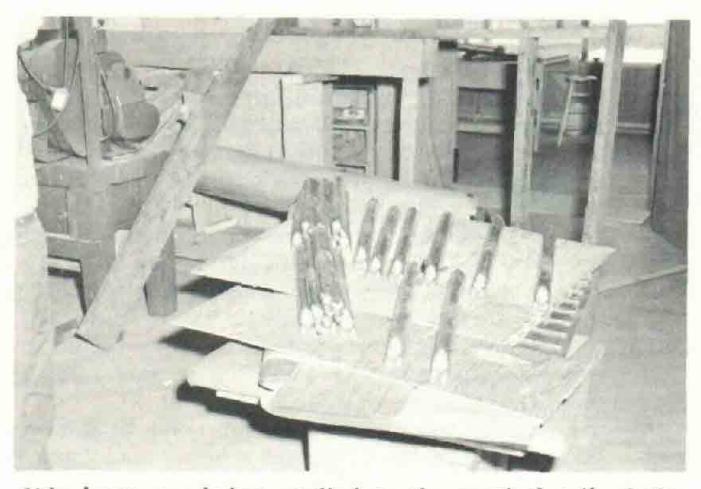
Side loads are being applied to the vertical tail of the Coot A. The boom and tail are rotated 90 degrees for this static test.

The test rig was then laid on its side and the vertical fin and rudder were tested in two loadings, along the leading edge of the fin and then on the rudder hinge line. While the bulk of the loads are along these lines, they are actually tapered out from these concentration areas fore and aft to Continued on Next Page

the leading edge and the trailing edge in semi-triangular patterns as far as weight is concerned. Anyone interested in loading should get a copy of Part 23 of the FAR, and the patterns are all drawn out for you. While the tail structure was on the test support, the control-surface static loads were also applied although these loads were in actuality not as high as the loads imposed during the vertical-tail and horizontal-tail loadings. The whole operation of statictesting the tail of the Coot A took about half a day after the test set-up was completed.

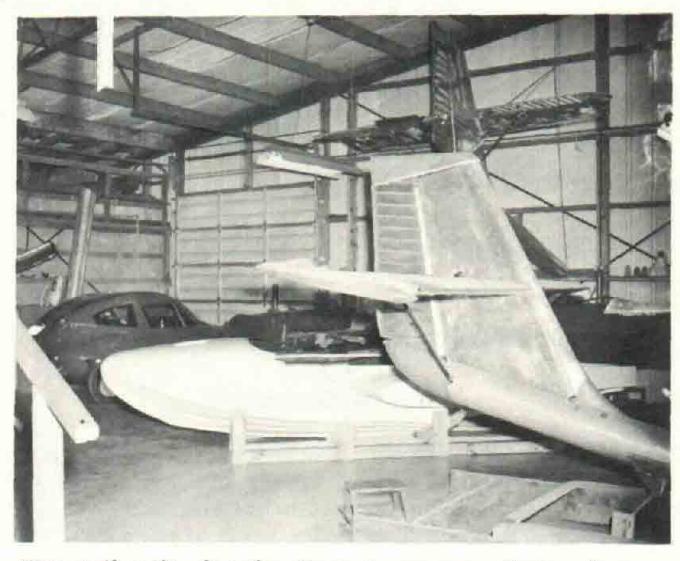
Two tail units for the Coot A are seen here, along with the prototype fiberglas hull shell for the Coot A.

The Coot A fiberglas hull shell is to be offered to the builder in the near future. Stiffeners and frames would have to be installed according to the drawings. Neither the Coot A nor the Coot B will lend themselves to a fourplace arrangement.

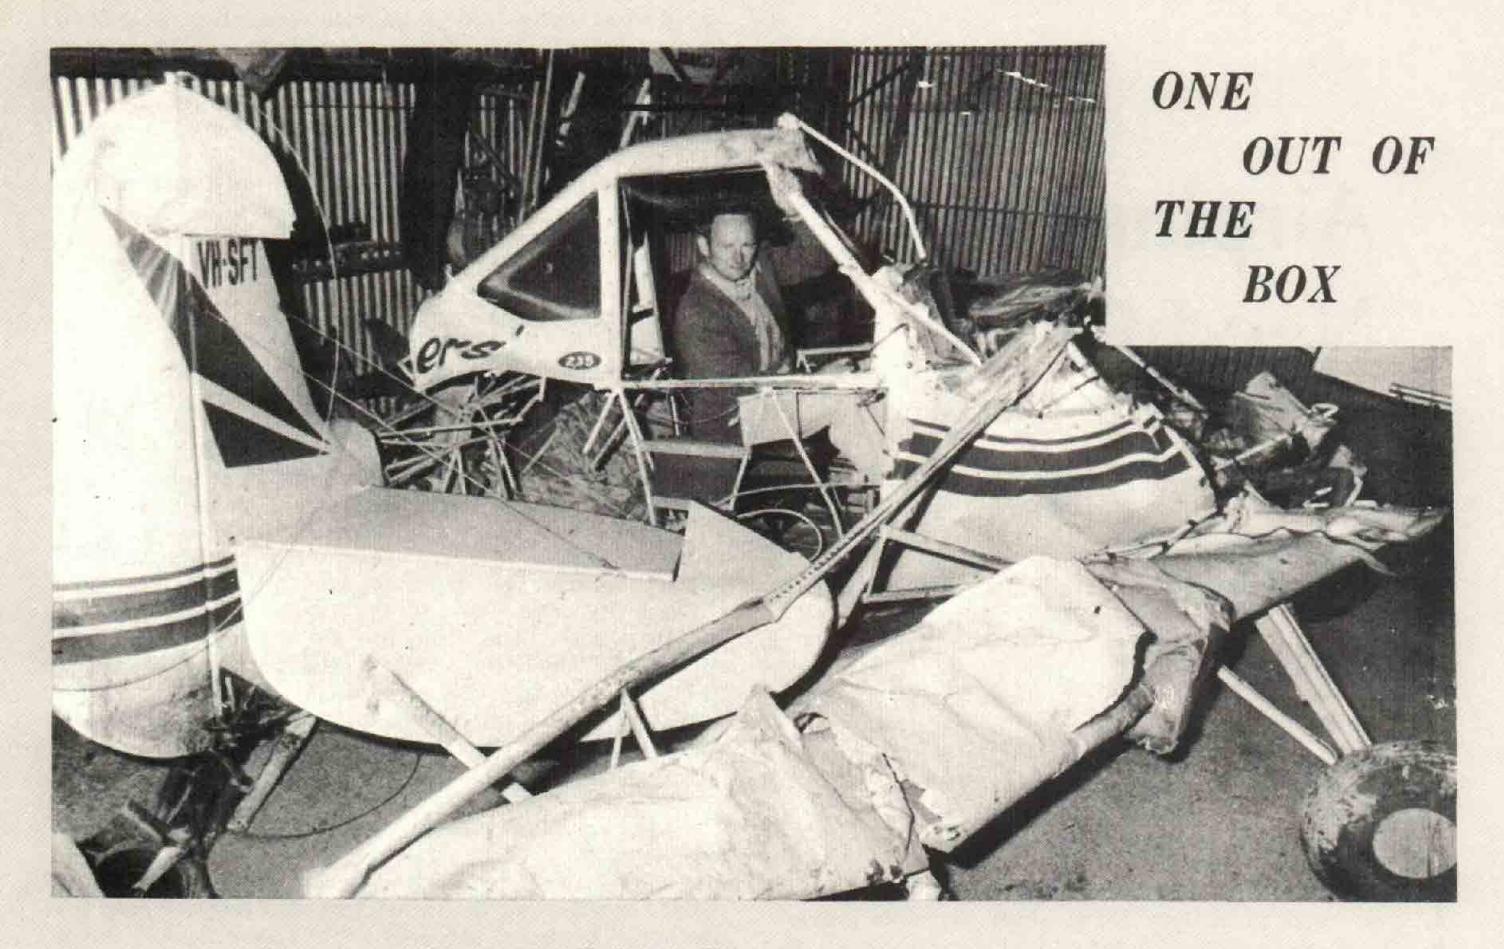
Early last fall, the tangle shown here was a Piper "Pawnee," VH-SFT, owned by Sky Farmers of Leongatha, Victoria, Australia.

Even the engine castings were shattered by the impact. Old hands said they had not before seen a live pilot leave such a badly mangled airplane. Piper's superbly strong cockpit capsule and the inertial shoulder harness must take much of the credit. But luck also played a part.
